Smoke and Dye Testing Summary

High Level Sewershed

Test ID	Test Type	Date Inspected	Company / Super.	Blower MH	Ground Condition	Notification Made?	Total Length
S1028-271	Smoke	9/2/2009	ADS/TM	S11MM1018MH	Dry	Yes	1,138.87

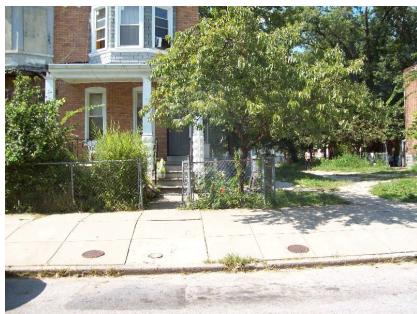
Picture \S1028-271-OB01-P01.jpg

Comments Smoke from cleanout in front yard. 3114 Woodland Ave.

Comments Front of house, 3114 Woodland Ave.

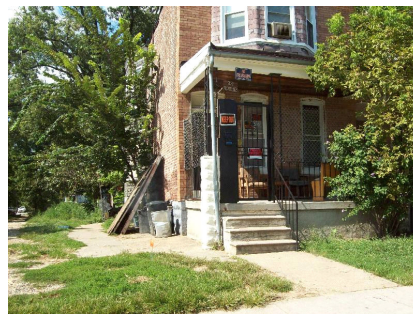
Picture \S1028-271-OB02-P01.jpg

Comments Smoke from cleanout in front yard. 3108 Woodland Ave.

Comments Front of house, 3108 Woodland Ave.

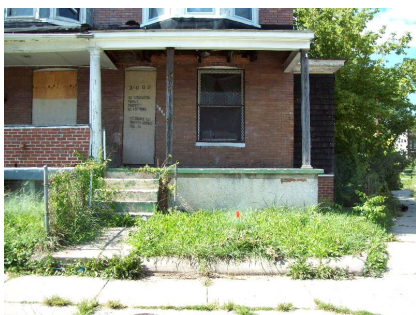
Picture \S1028-271-OB03-P01.jpg

Comments Smoke from cleanout in front yard. 3000 Woodland Ave.

Comments Front of house, 3000 Woodland Ave.

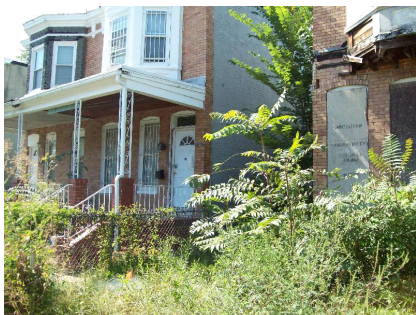
Picture \S1028-271-OB05-P01.jpg

Comments Smoke from cleanout in front yard. 3116 Woodland Ave.

Comments Front of house, 3116 Woodland Ave.

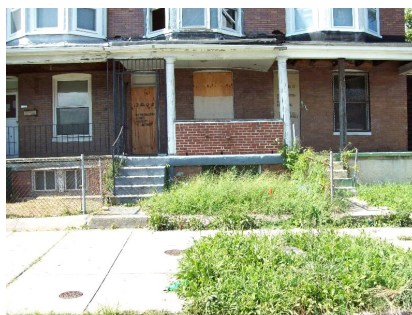
Picture \S1028-271-OB04-P01.jpg

Comments Smoke from cleanout in front yard. 3002 Woodland Ave.

Comments Front of house, 3002 Woodland Ave.

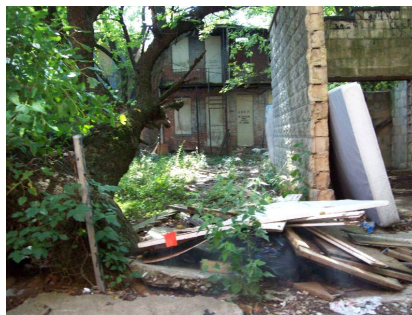
Picture \S1028-271-OB06-P01.jpg

Comments Smoke from service lateral in back yard. 4805 Park Heights Ave.

Comments Back of house, 4805 Park Heights Ave.

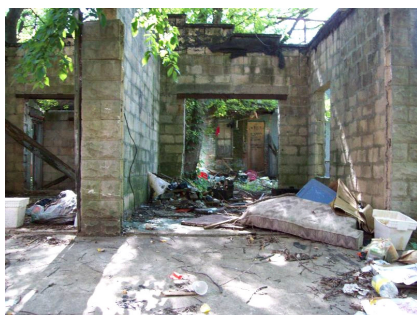
Picture \S1028-271-OB07-P01.jpg

Comments Smoke from cleanout in paved concrete behind house. 4809 Park Heights Ave.

Comments Back of house, 4809 Park Heights Ave.

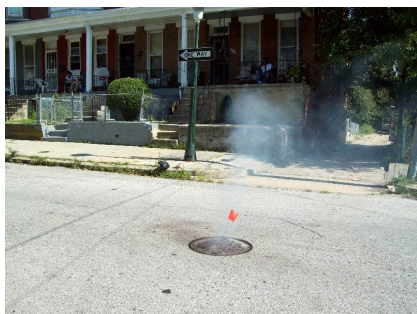
Picture \S1028-271-OB09-P01.jpg

Comments Smoke from sanitary manhole S11MM1023MH (vented lid) in paved asphalt in front of 3129 Woodland Ave.

Comments Front of house, 3129 Woodland Ave.

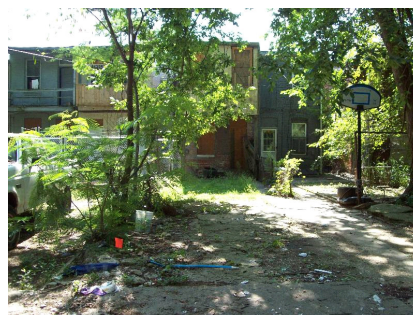
Picture \S1028-271-OB08-P01.jpg

Comments Smoke from service lateral under paved concrete behind house. 4817 Park Heights Ave.

Comments Back of house, 4817 Park Heights Ave.

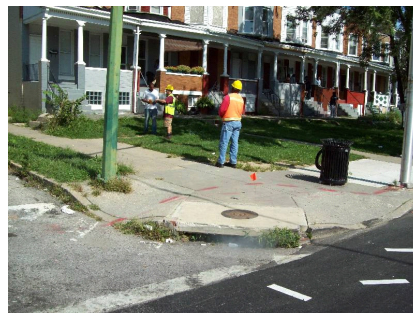
Picture \S1028-271-OB10-P01.jpg

Comments Smoke from catch basin along curb in front of 4755 Park Heights Ave.

Comments Park Heights Ave. & Woodland Ave. looking southeast

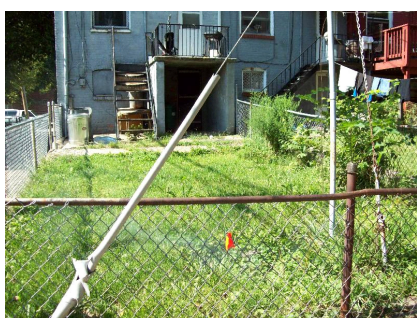
Picture \S1028-271-OB11-P01.jpg

Comments Smoke from service lateral in back yard. 3129 Woodland Ave.

Comments Back of house, 3129 Woodland Ave.
